July 8, 2019
Triterra Project #: 19-2171-02

**SUBJECT: *Asbestos-Containing Materials Inspection and Hazardous Materials Survey
1015 Albert Avenue, Kalamazoo, Michigan 49048***

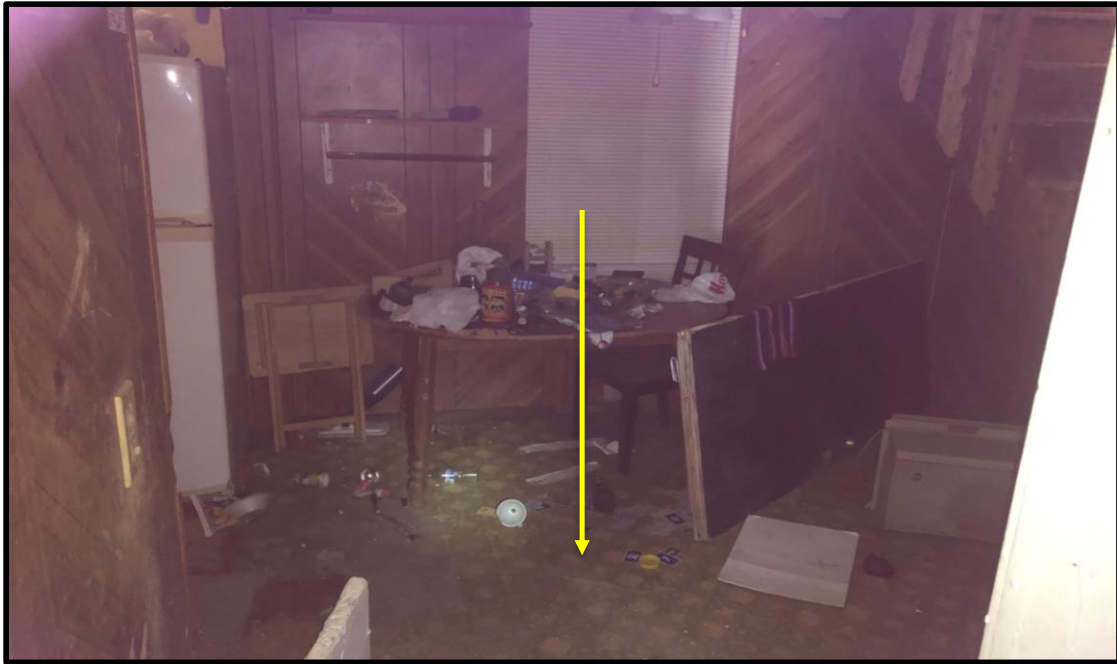
- Category I non-friable ACM is defined as packings, gaskets, resilient floor coverings, and asphalt roofing products containing 1 percent or greater asbestos. Category I non-friable ACM identified during the inspection, include:
 - **HA 2:** *Green flooring with a white square pattern* located in the 1st floor hall and dining room (photo 1);
 - **HA 6:** *White linoleum flooring* in the 1st floor bathroom under portions of HA 5;
 - **HA 18:** *White, brick-patterned floor tile* in the 1st floor bedroom (photo 2), and;
 - **HA 19:** *9x9-inch white, rock-patterned floor tile* in the basement.

PHOTO: 1 **DATE: 6/12/2019** **BY: Greg Ross**
SUBJECT: HA 2: Asbestos-containing green flooring (with white square pattern) in the 1st floor hallway and dining room.

Based on Triterra’s understanding of the demolition activities planned for the Property, proper abatement of the friable *duct wrap (HA 17)* and the *plaster walls & ceilings (HA 13)* is required prior to commencing these activities. Additionally, the removal of Category I non-friable materials (and non-ACM hazardous materials) is strongly recommended prior to demolition as these materials may become friable during these activities.

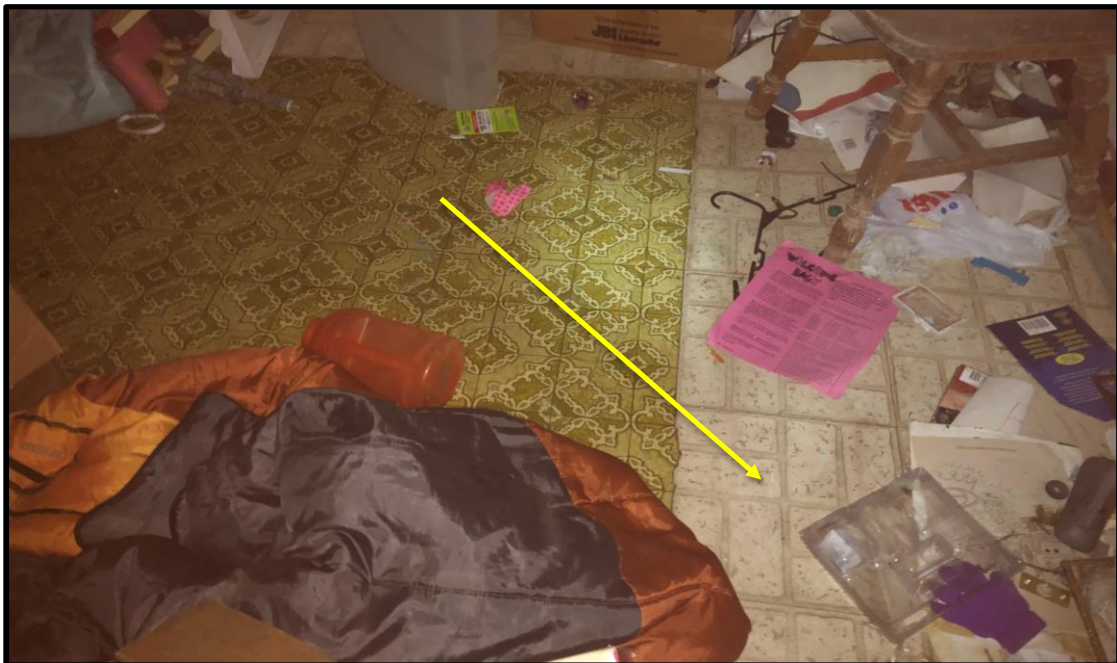
PHOTO: 2 **DATE: 6/12/2019** **BY: Greg Ross**
SUBJECT: HA 18: Asbestos-containing white floor tile in the first floor bedroom.
