July 8, 2019
Triterra Project #: 19-2171-05

**SUBJECT: *Asbestos-Containing Materials Inspection and Hazardous Materials Survey
3408 Hoover Street, Kalamazoo, Michigan 49008***

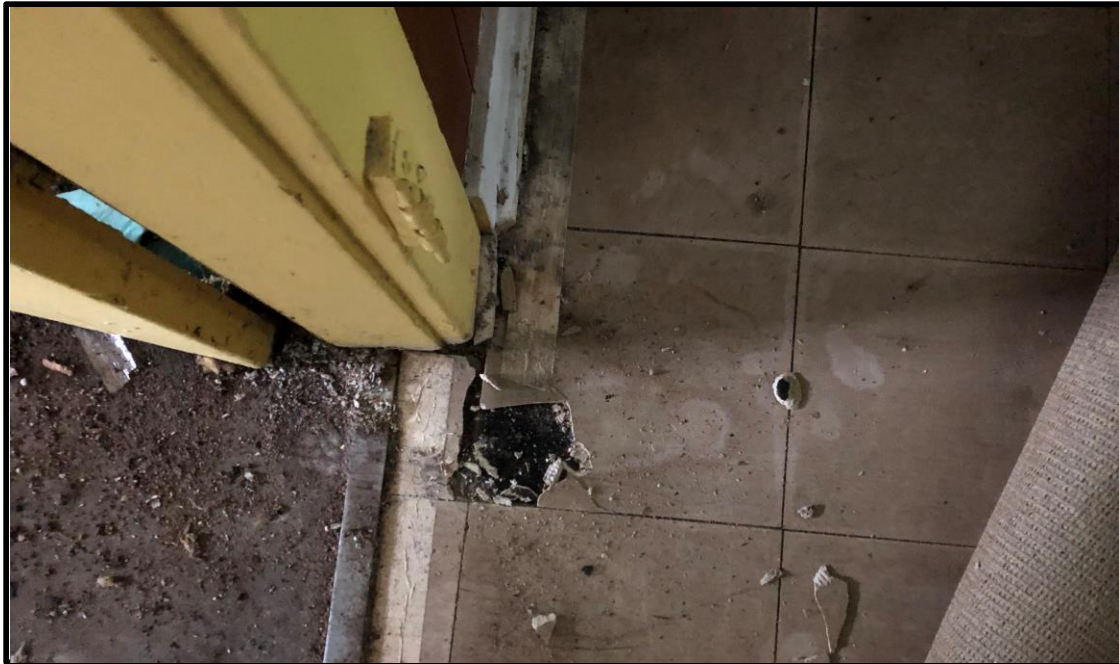
- Category I non-friable ACM is defined as packings, gaskets, resilient floor coverings, and asphalt roofing products containing 1 percent or greater asbestos. Category I non-friable ACM identified during the inspection, include:
 - **HA 5:** *9x9-inch tan floor tile* and underlying mastic under the carpet by the back door (Photo 1), and;
 - **HA 10:** *Adhesive* on the ceramic tile backsplash in the kitchen (Photo 2).

PHOTO: 1 **DATE: 6/13/2019** **BY: Greg Ross**
SUBJECT: HA 5: Asbestos-containing 9x9-inch tan floor tile and underlying mastic, under carpeting by back door.

Based on Triterra’s understanding of the demolition activities planned for the Property, proper abatement of the Category II non-friable *joint compound* (**HA 13**) and *sink undercoating* (**HA 14**) is required prior to commencing these activities. Additionally, the removal of Category I non-friable materials (and non-ACM hazardous materials) is strongly recommended prior to demolition as these materials may become friable during these activities.

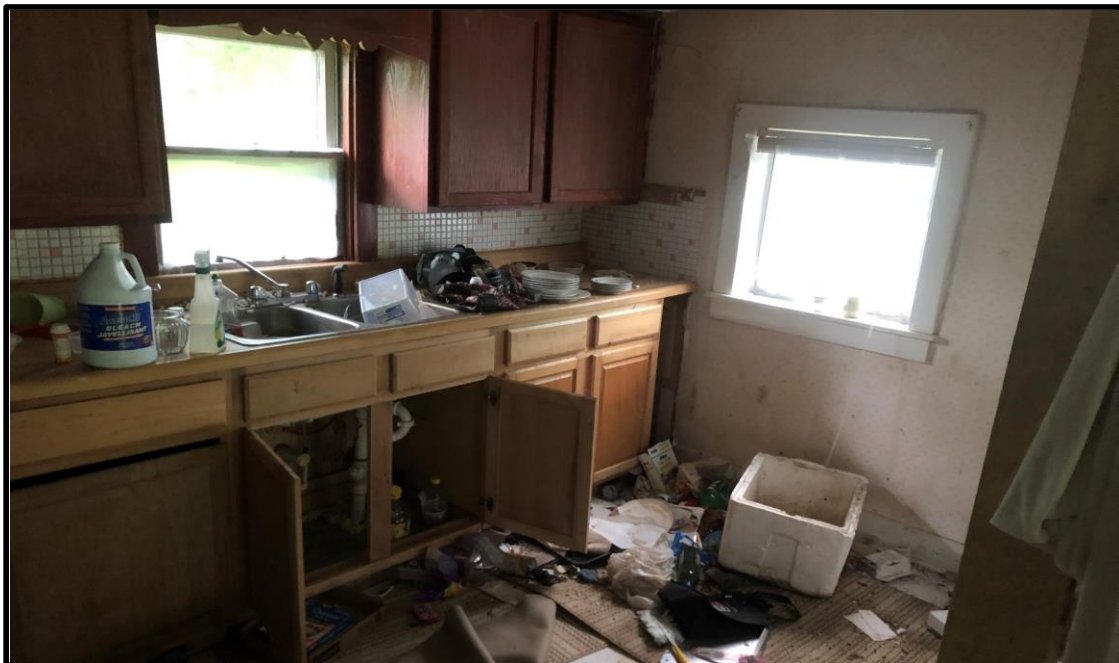
PHOTO: 2 **DATE: 6/13/2019** **BY: Greg Ross**
SUBJECT: HA 10: Asbestos-containing adhesive on the ceramic tile backsplash in the kitchen.
