July 8, 2019
Triterra Project #: 19-2171-03

**SUBJECT: *Asbestos-Containing Materials Inspection and Hazardous Materials Survey
517 Lulu Street, Kalamazoo, Michigan 49007***

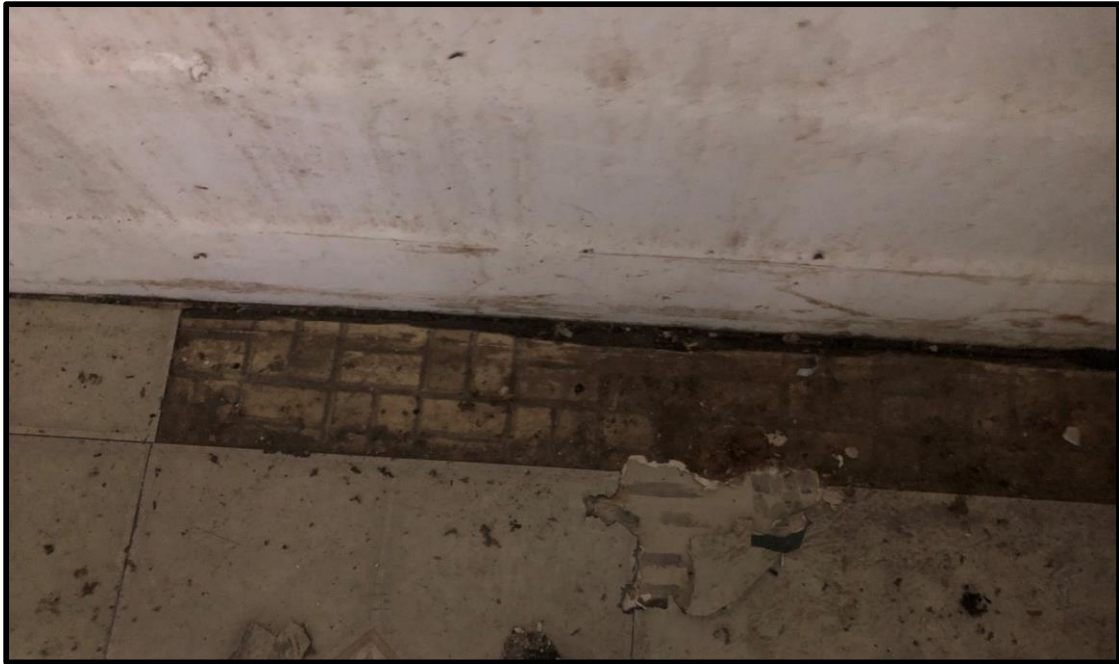
- **HA 3:** *Yellow/tan laminate flooring with a rectangle pattern* in the 1st floor bathroom under the 12x12-inch white floor tile (HA 2) (Photo 1);
- Category II non-friable ACM is defined as any other non-friable material containing 1 percent or greater asbestos, excluding category I non-friable ACM. No Category II non-friable ACM was identified during the inspection.

PHOTO: 1 **DATE: 6/12/2019** **BY: Greg Ross**
SUBJECT: HA 3: Asbestos-containing yellow/tan laminate flooring with a rectangle pattern - 1st floor bathroom under HA 2.

Based on Triterra’s understanding of the demolition activities planned for the Property, proper abatement of the friable *duct wrap* (**HA 9**) is required prior to commencing these activities. Additionally, the removal of Category I non-friable materials (and non-ACM hazardous materials) is strongly recommended prior to demolition as these materials may become friable during these activities.

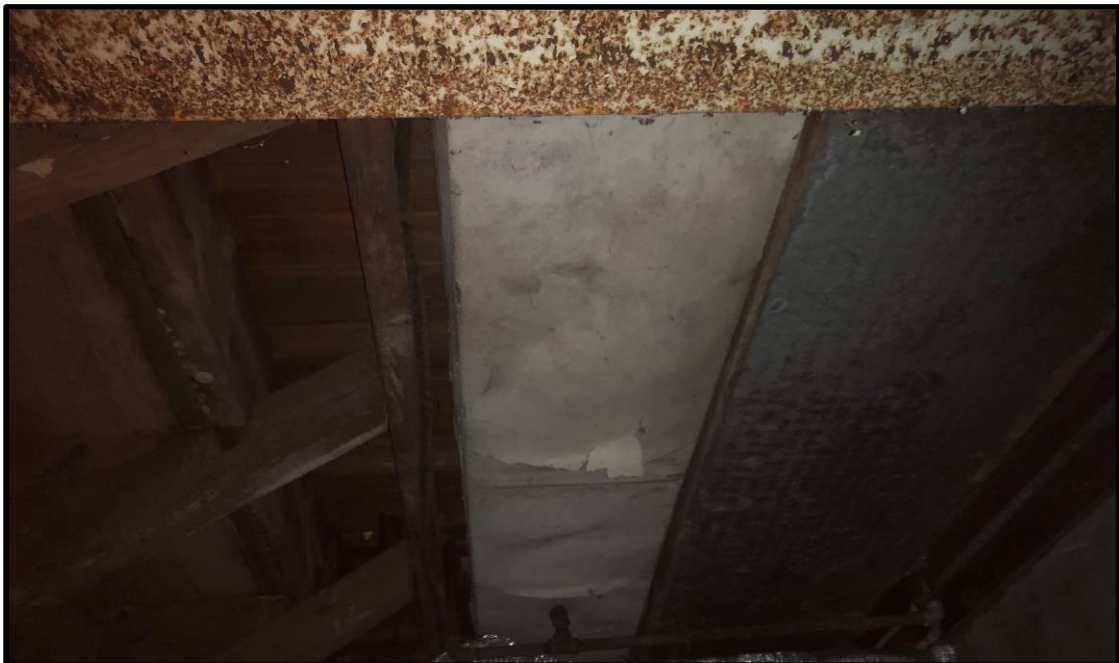
- **HA 9:** *Duct wrap* on a vent run in the basement (Photo 2).

PHOTO: 2 **DATE: 6/12/2019** **BY: Greg Ross**
SUBJECT: HA 9: Presumed asbestos-containing duct wrap on a basement ventilation run.
